## Project Test Project

Tuesday, 17 December 2024

101 Issues Identified

F.A.B. Snagging

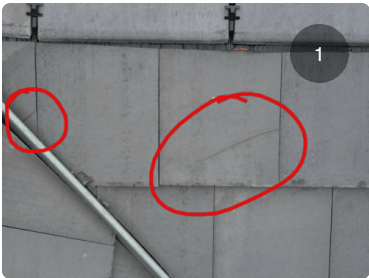
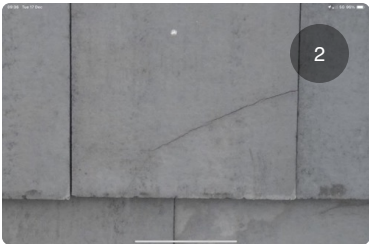
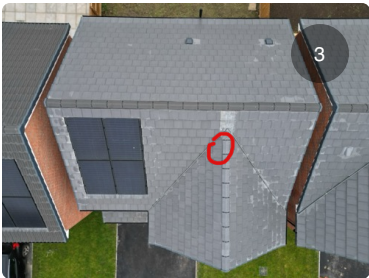
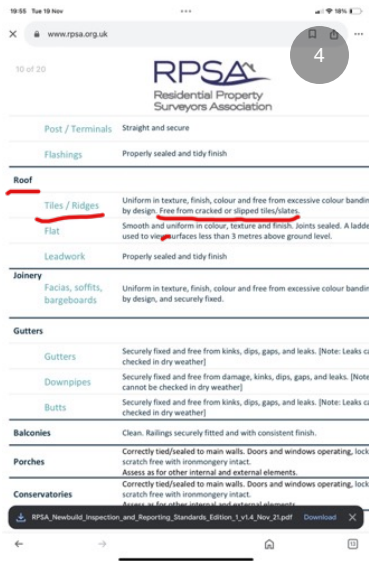
Issue 1

Two broken tiles, front of house.

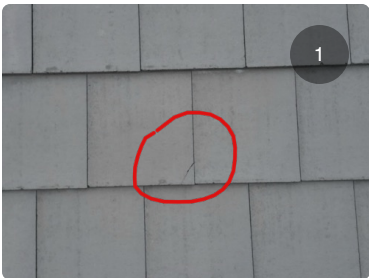
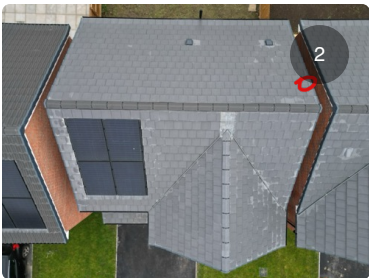
Issue 2

Broken tile, back of house.

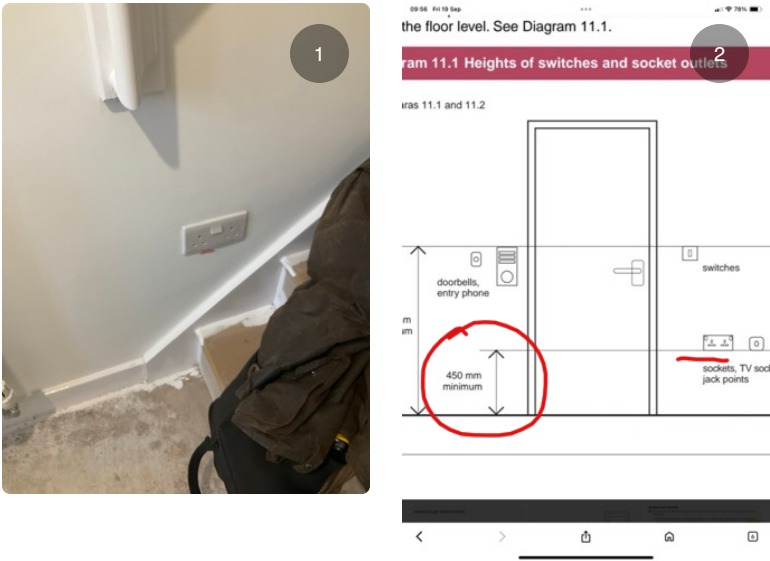
Issue 8

Socket appears to be in the wrong place.

I don't think it will be here on the plans. Too low if you count the stair as ground level. 450 to 1200mm from ground.

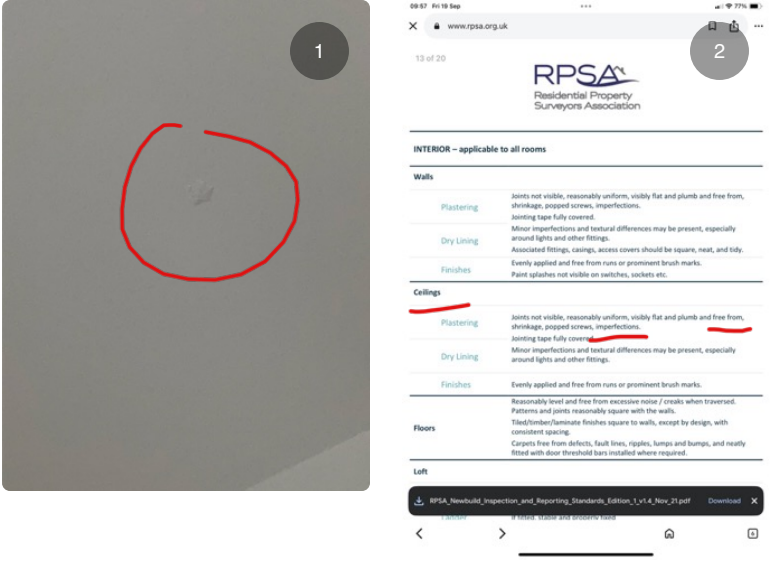
Issue 9

Decoration, living room ceiling.

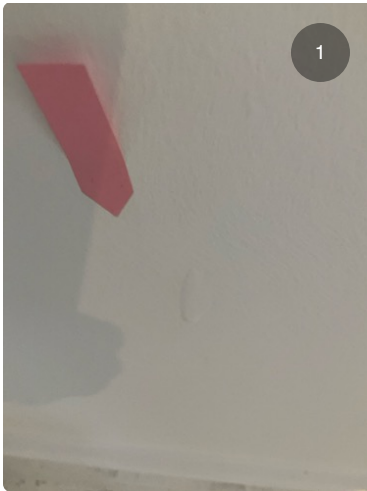
## Issue 14

Screw cover missing, media panel.

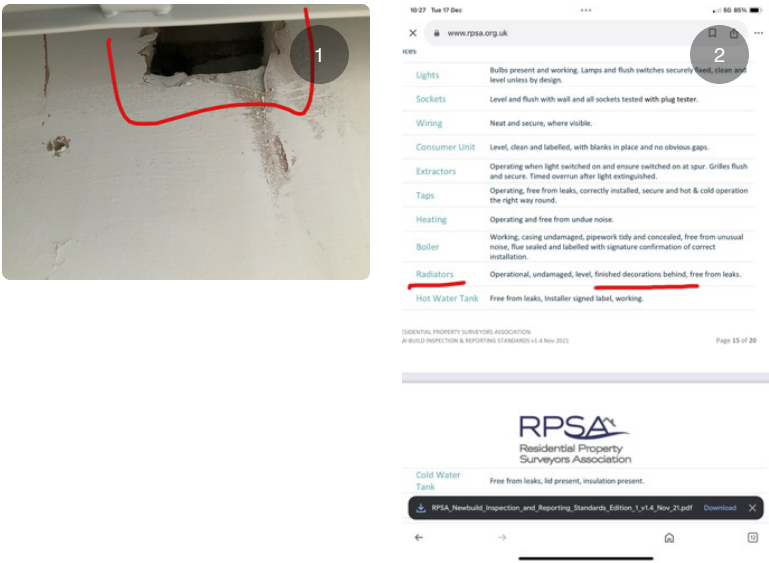
Issue 17

Large hole in the wall, behind living room radiator.

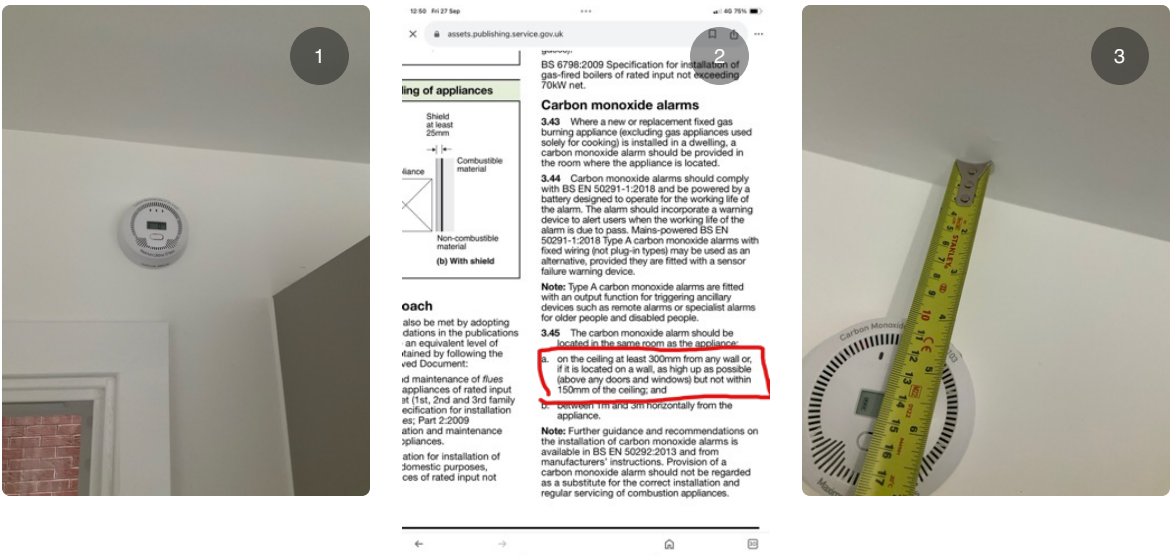
Issue 18

There is no need for a CO detector in the kitchen, as no gas appliance other than hob - which doesn't require one.

However , when they are fitted, they should be 150 mm from the ceiling. Building regulations.

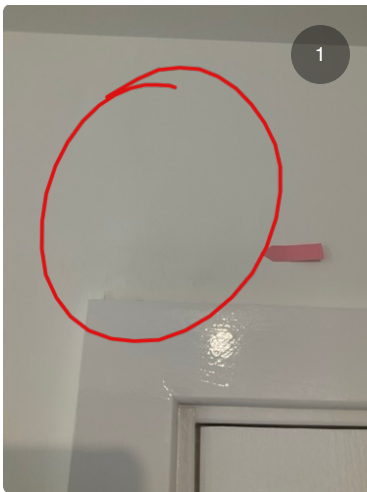
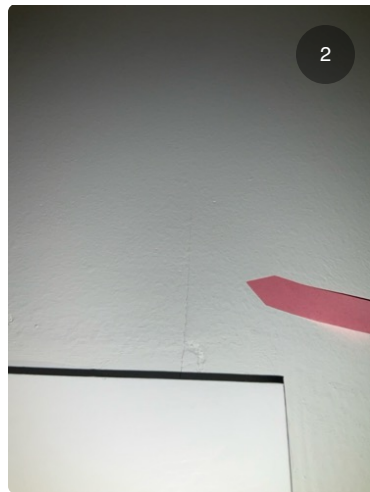
### Issue 22

Lump & crack in wall, above under stairs cupboard.

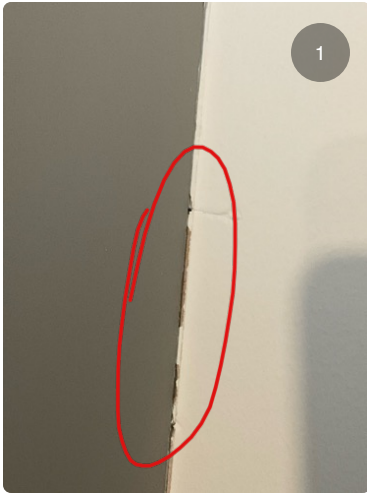
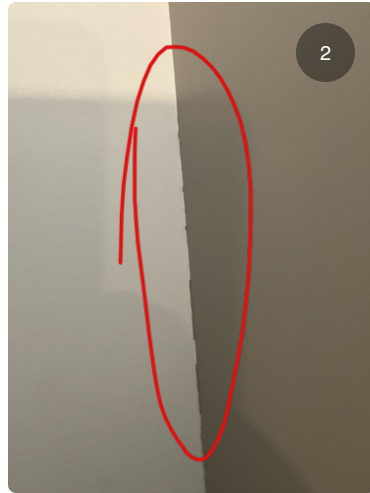
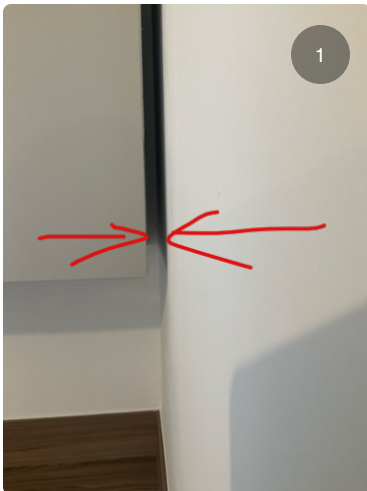
### Issue 23

Wall cabinets, either side of extractor not sealed to the wall. Bare plasterboard showing.

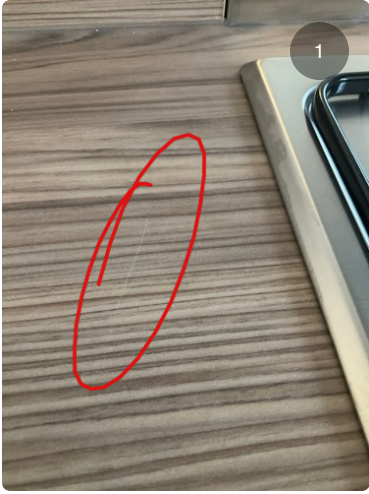
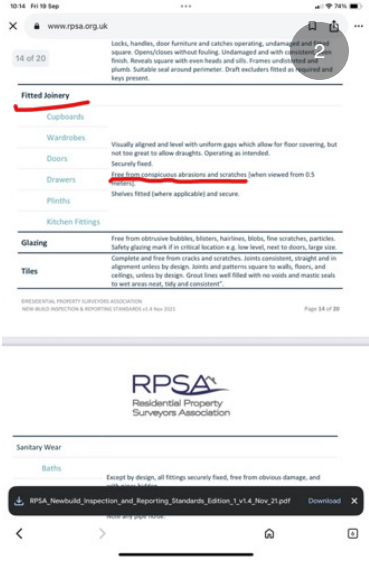
Issue 26

Scratch on worktop.

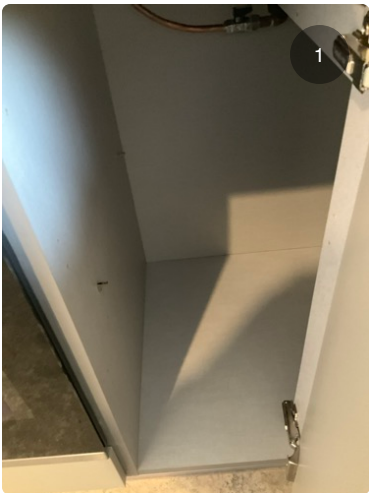
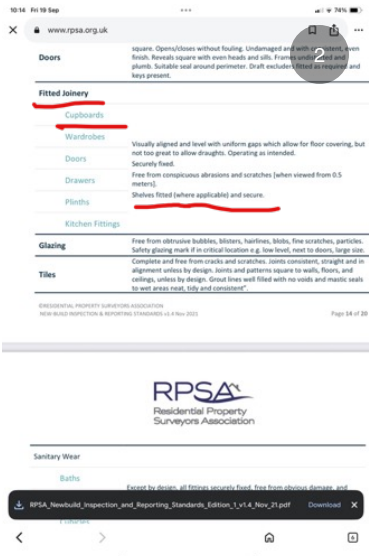
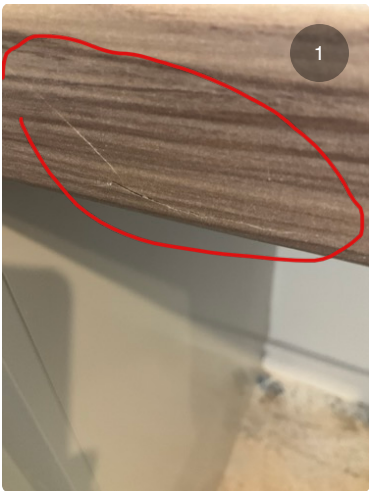
Issue 27

Shelf missing from corner cabinet.

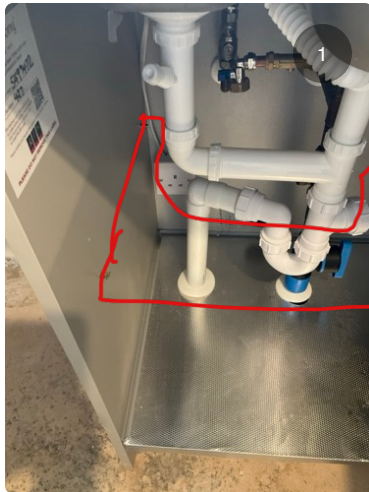
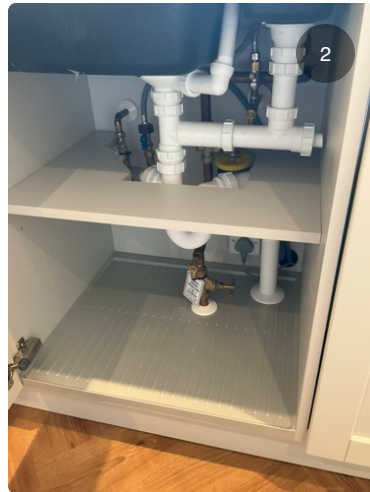
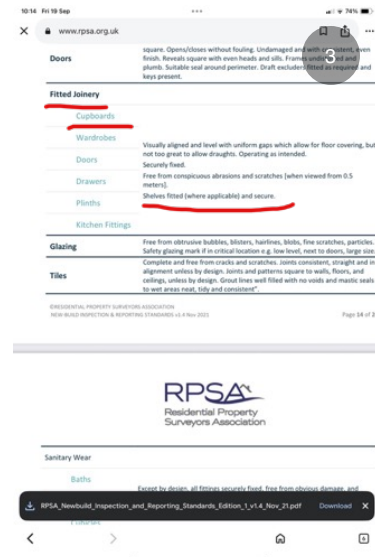
## Issue 33

Cabinet under the sink, was supplied with a shelf. It should be cut to fit around the pipework and install installed.

Picture two for reference .

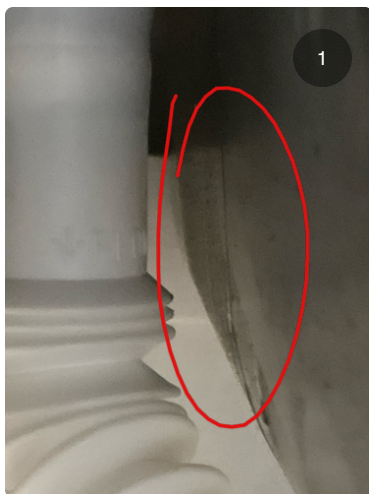
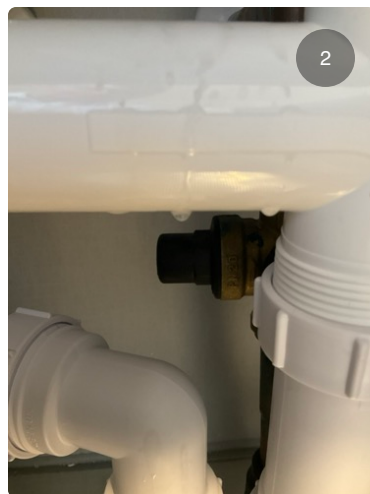
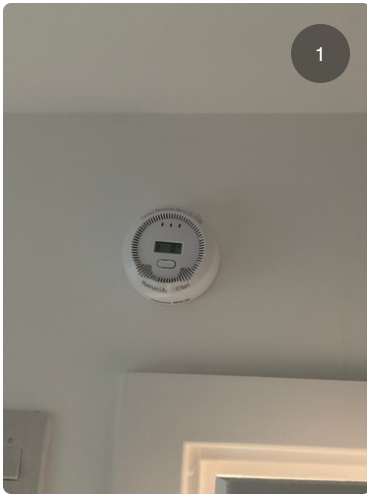
## Issue 34

Water is leaking from kitchen sink overflow. It's quite slight but it is leaking.

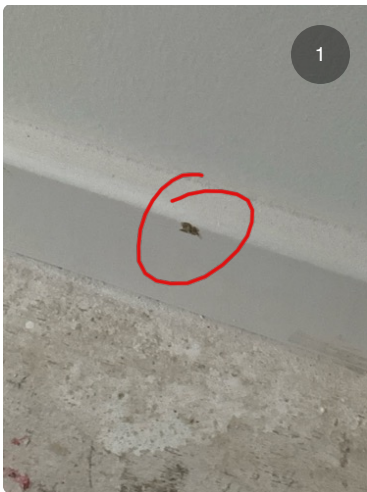
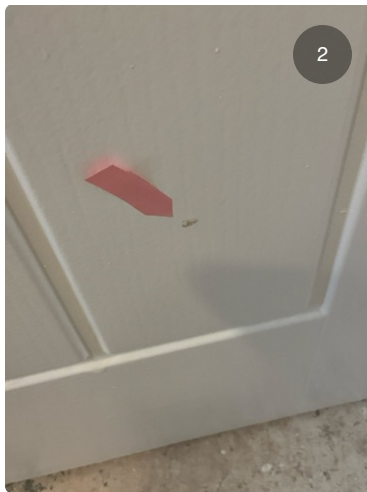
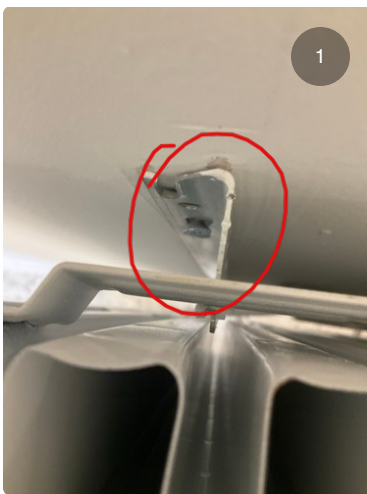
### Issue 36

Decoration, utility.

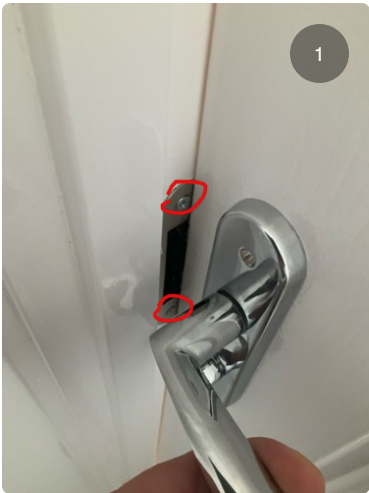
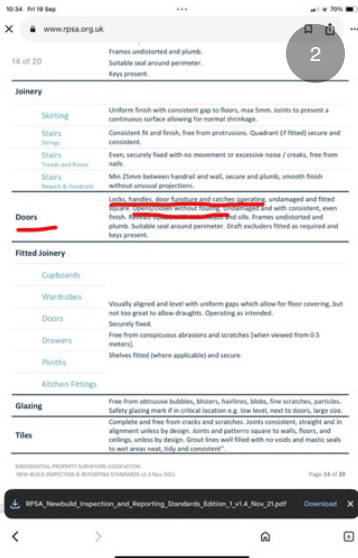
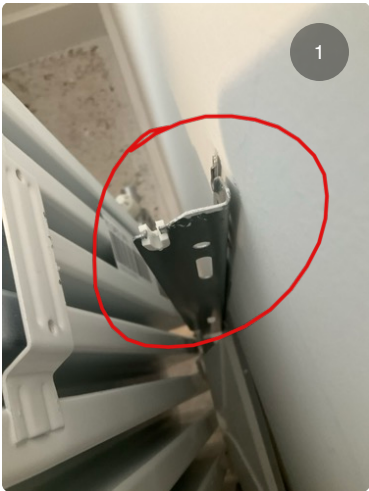
Issue 41

Downstairs toilet door, is catching on latch plate.  
I think on the screws.

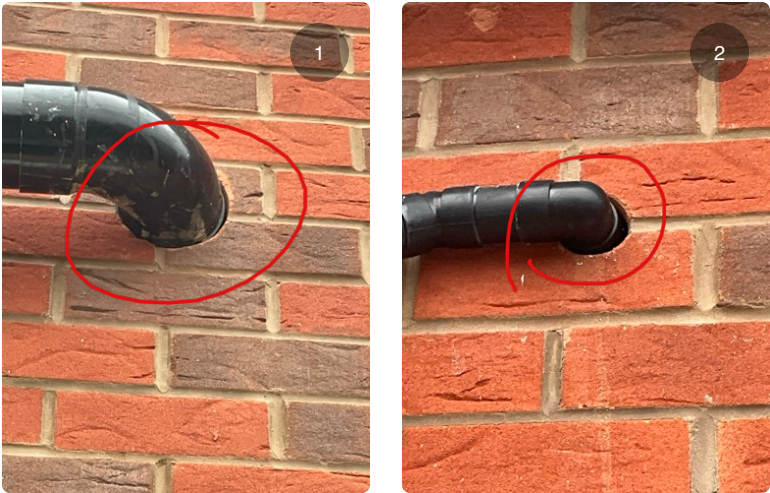
Issue 45

Not sealed around soil pipe and waste pipe, back of house.

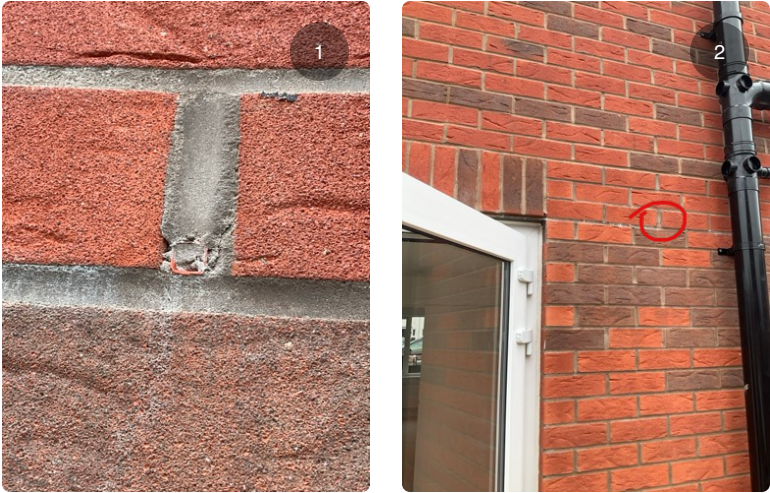
Issue 46

Weep hole blocked, patio door cavity tray.

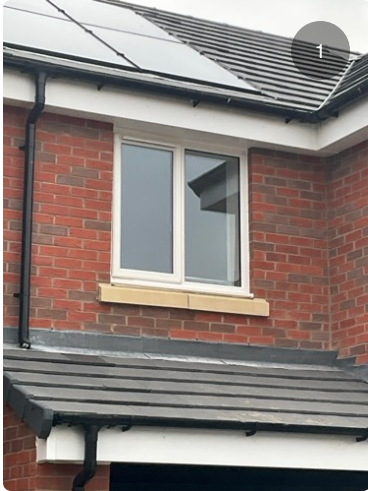
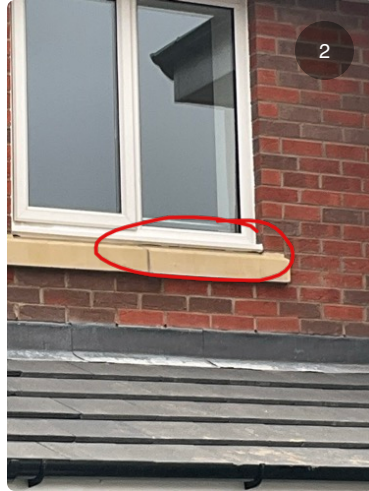
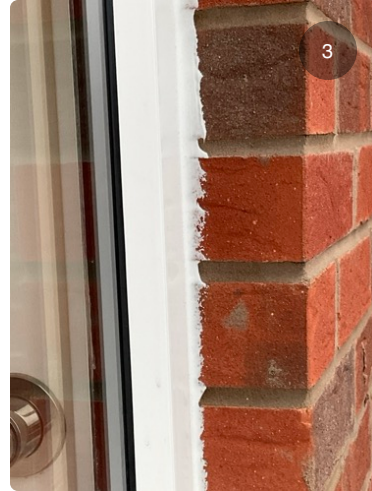
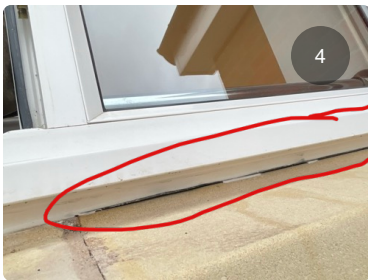
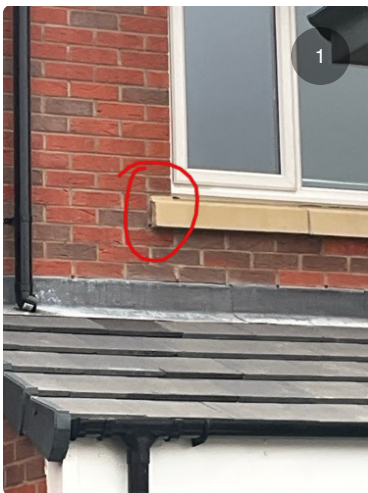
### Issue 53

This window looks like it was sealed with silicone not mastic.

The seal underneath has failed.

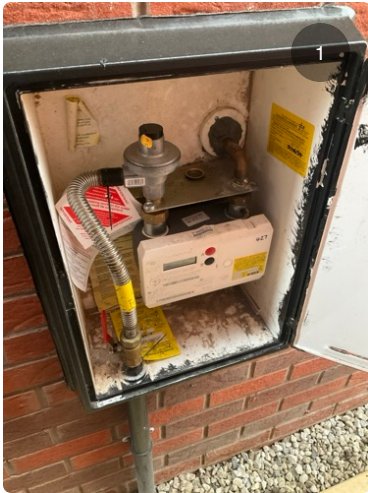
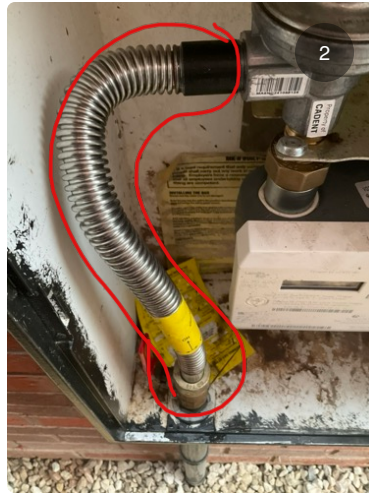
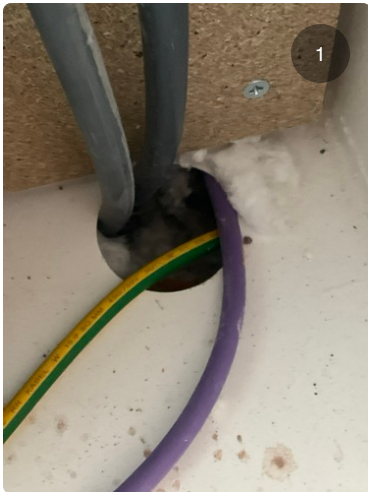
## Issue 59

I can smell gas in gas meter housing. Site has been informed, Cadent are on the way.

It was the silver pipe(Anaconda), which has been replaced, and whole house checked over.

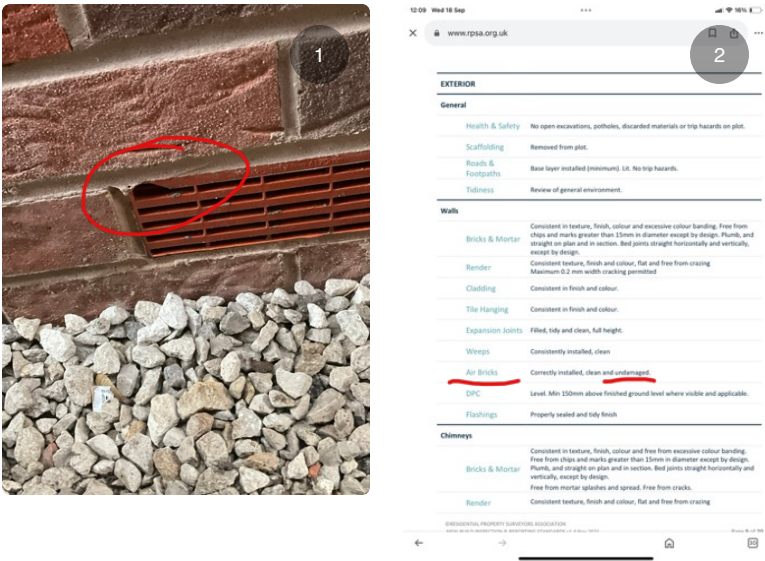
Issue 61

Air brick damaged. Left side of house.

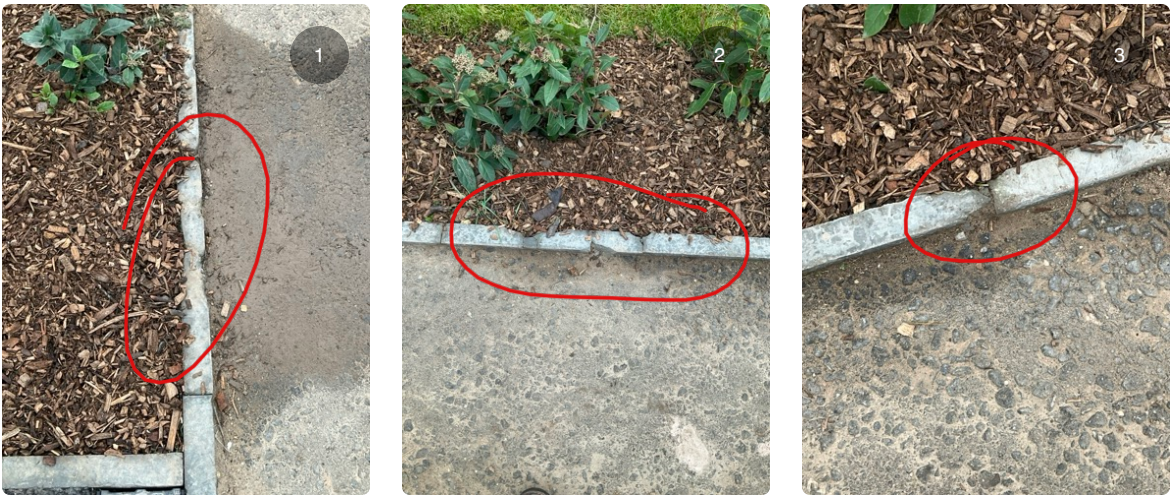
Issue 62

Edging stones damaged top of front garden.

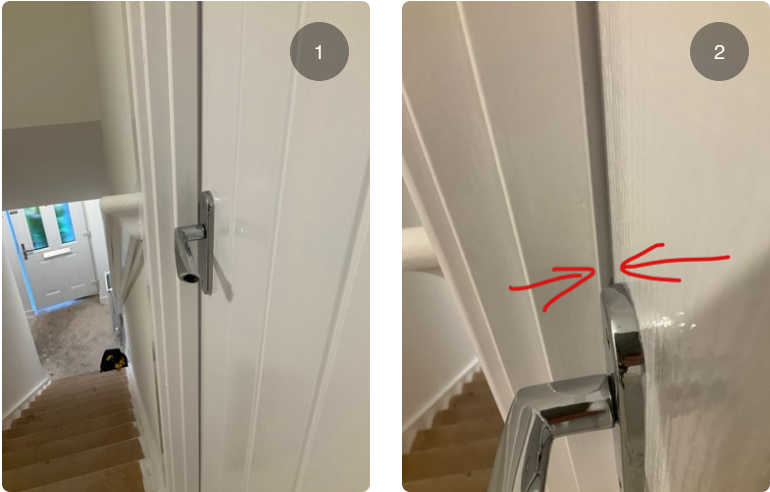
Issue 63

Bedroom one door or frame bowed, have to pull hard to engage latch.

(Bedroom one, counted clockwise from the top of the stairs)

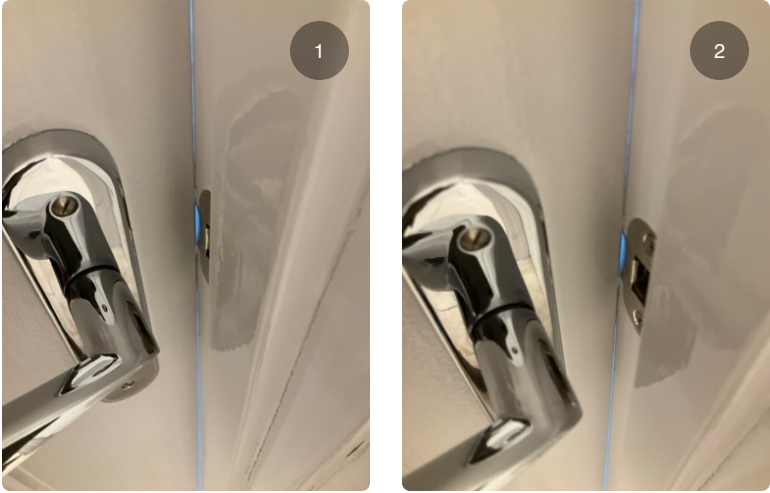
Issue 64

Bedroom two door, hitting door frame.

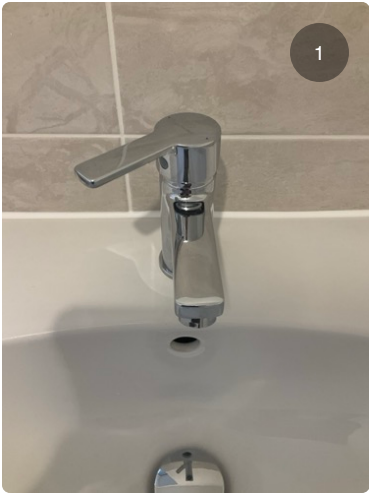
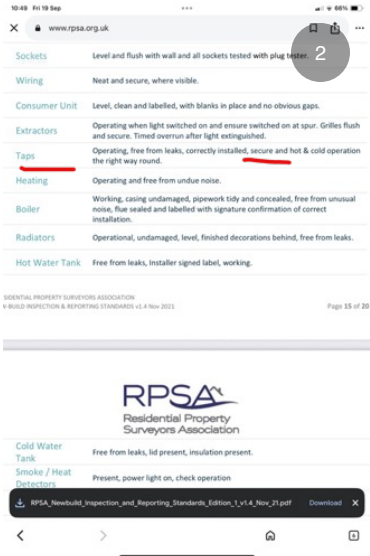
Issue 82

Family bathroom, basin tap loose.

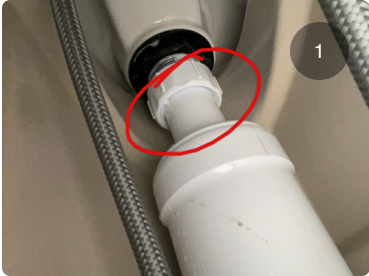
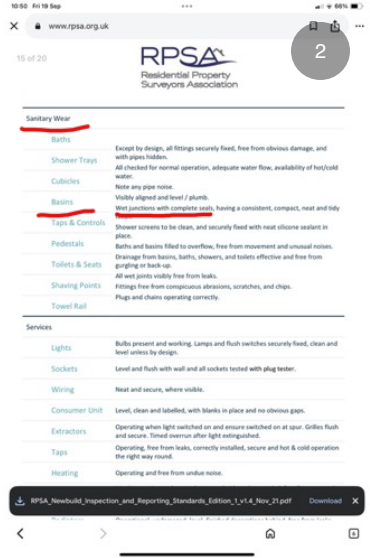
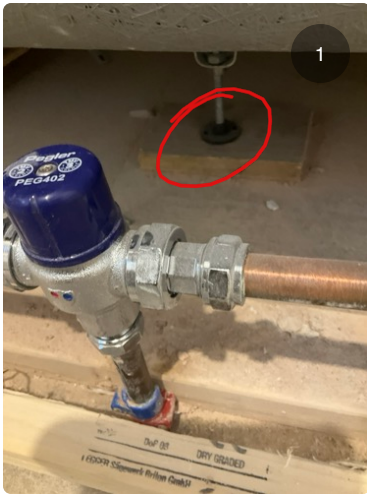
Issue 83

Leak to family bathroom basin.

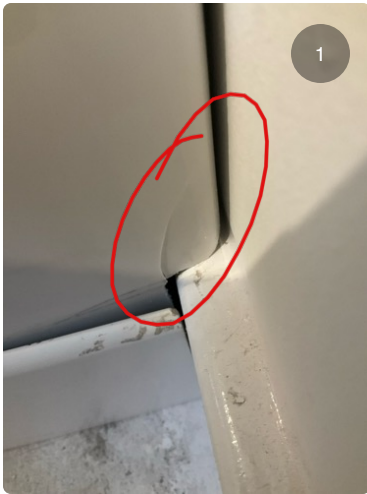
### Issue 86

Bath panel has been cut for skirting both sides. I guess that's why it's got the trim.

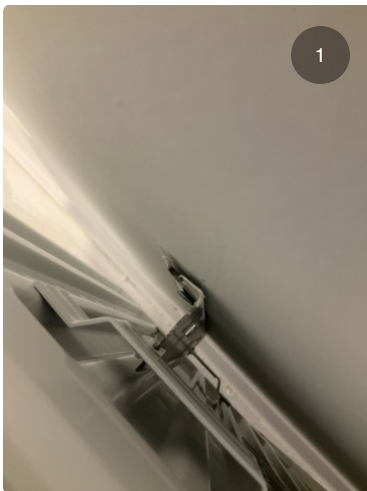
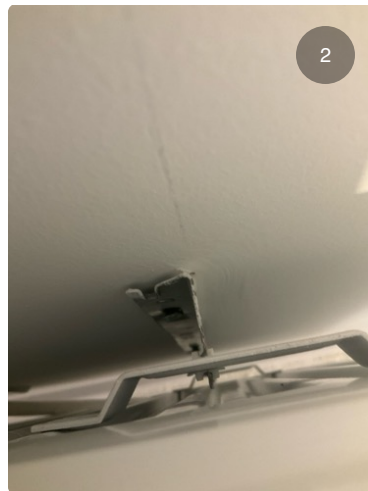
### Issue 94

Master bedroom, radiator brackets loose.

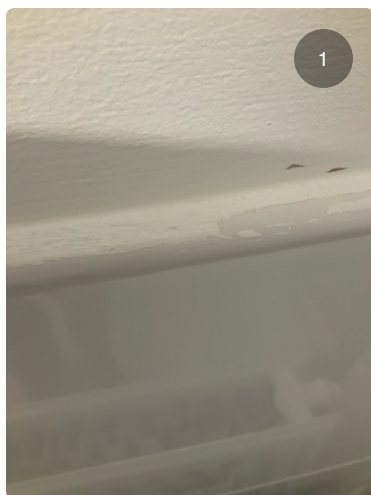
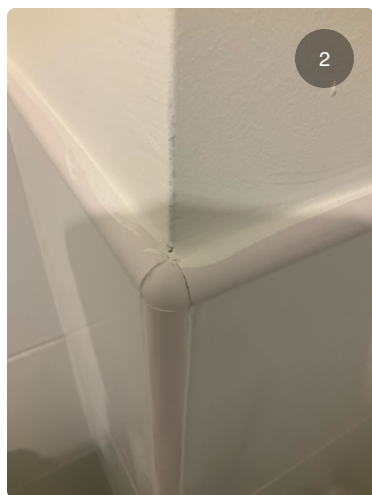
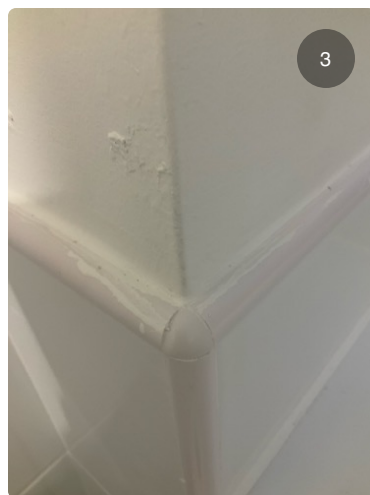
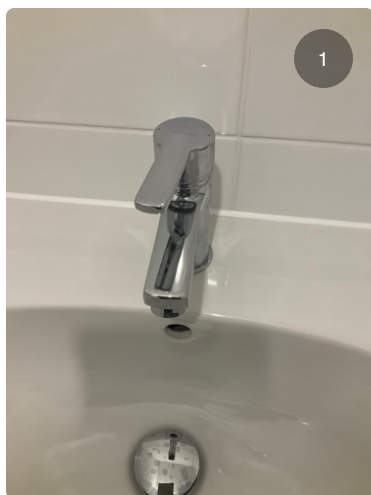
### Issue 97

Decoration generally untidy. A beginner could paint better than that.

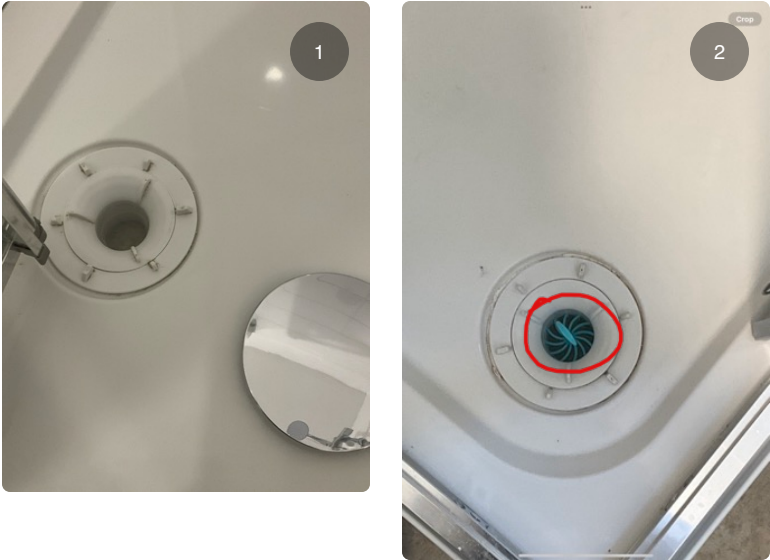
Issue 99

Strainer missing from ensuite shower.

Picture two for reference .

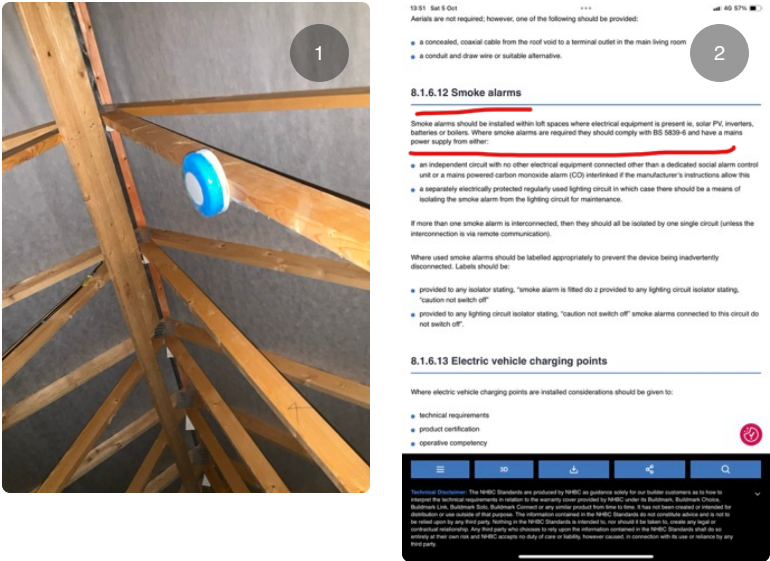
Issue 100

It's usual to put a combination heat/smoke detector in loft when there is electrical equipment.

Here we have just a smoke detector, but this won't work until the blue cover is removed, so effectively there is no alarm in the loft space.
