## Project Test Project

Tuesday, 17 December 2024

101 Issues Identified

F.A.B. Snagging

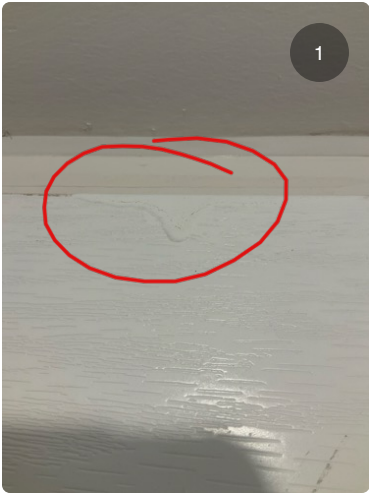
Issue 3

Paint run on front door.

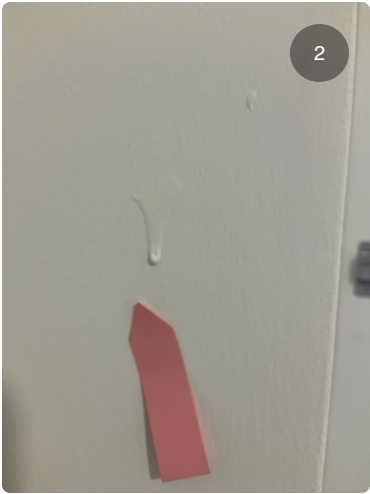
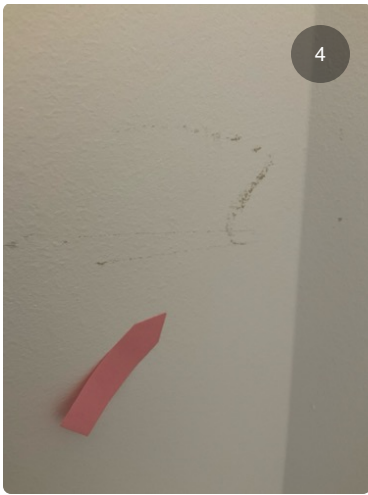
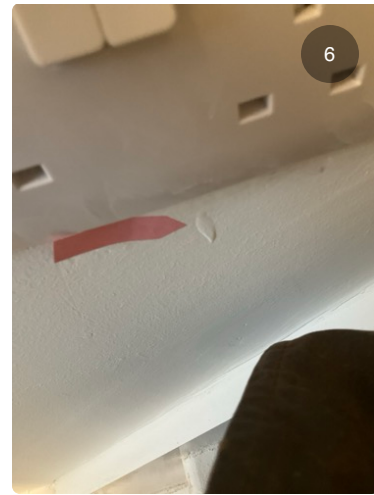
Issue 4

Decoration, hallway.

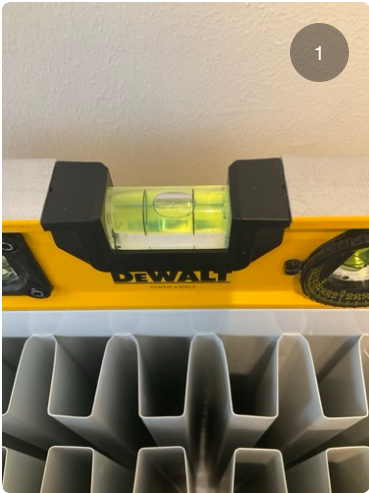
Issue 6

Hallway radiator, not level.

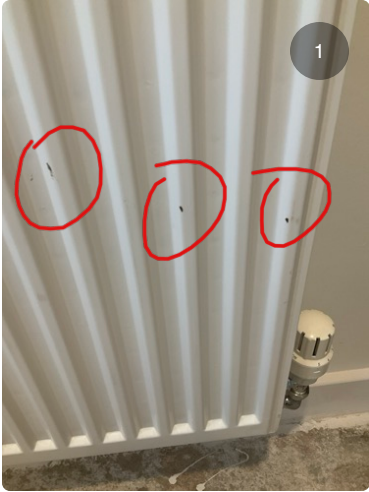
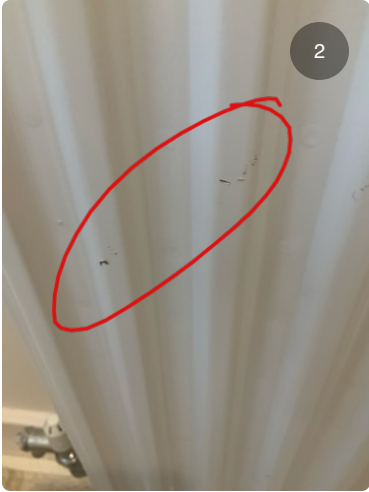
Issue 7

Paint chips in hallway radiator.

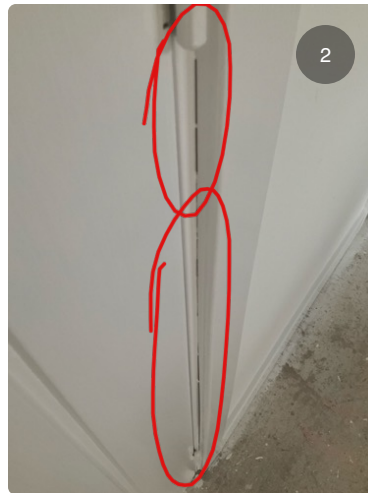
## Issue 12

Gaps between door frame and architrave, double doors.

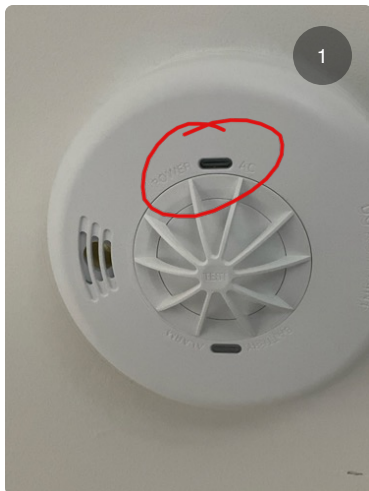
## Issue 13

No AC power, kitchen heat detector.

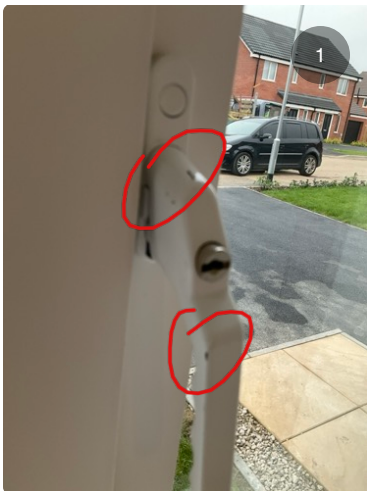
## Issue 15

Paint scratches, on living room window handle.

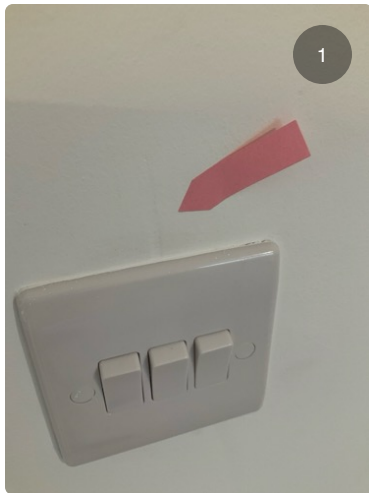
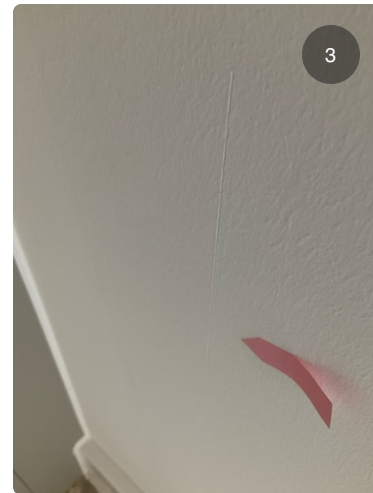
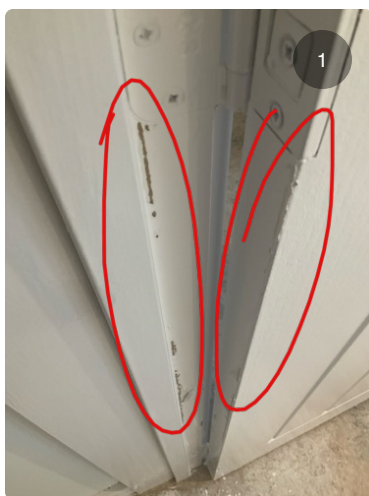
## Issue 19

Decoration, kitchen.

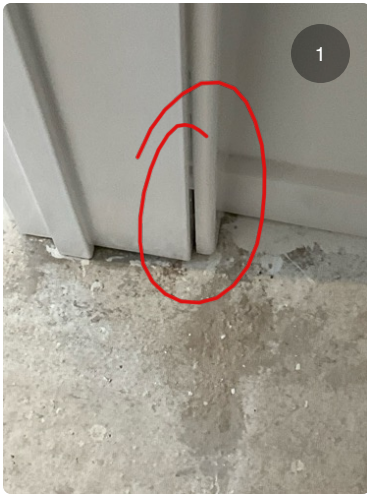
## Issue 20

Paintwork, under stairs cupboard door, and door frame.

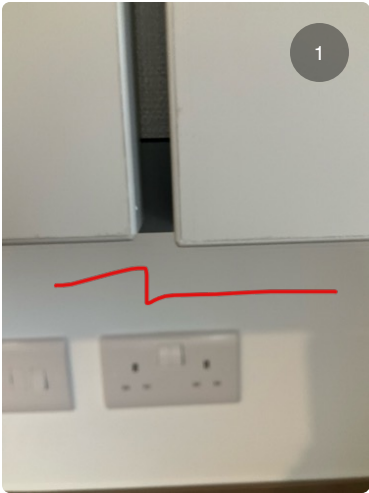
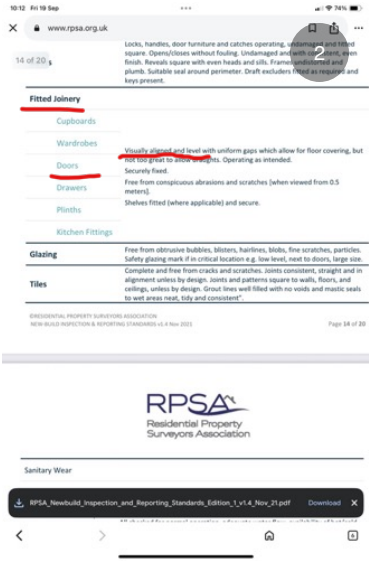
Issue 25

Kitchen cabinets, not level.

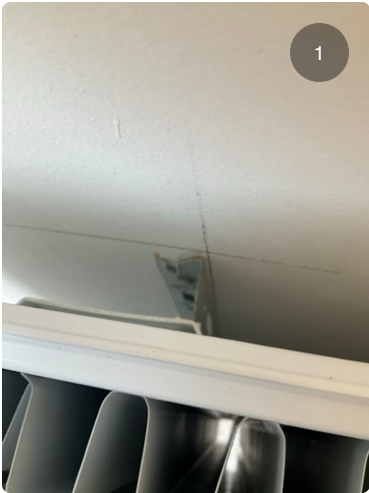
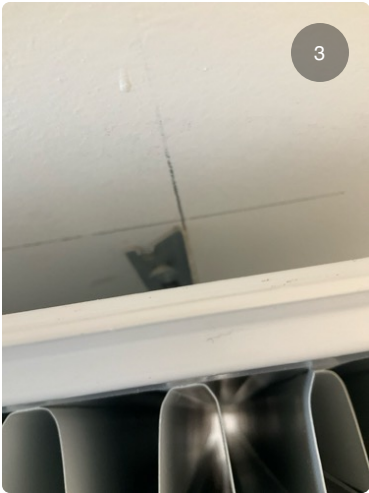
Issue 29

Pencil lines, behind kitchen radiator.

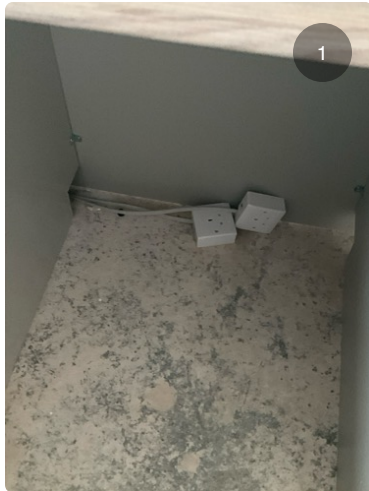
## Issue 31

Sockets should be fitted to 'THE FABRIC OF THE BUILDING'. 18th Edition Wiring regulations. Kitchen cabinets do count as the fabric of the building.

Also trailing cables are not allowed. These count as Clipped Direct, and should be clipped every 300 mm.

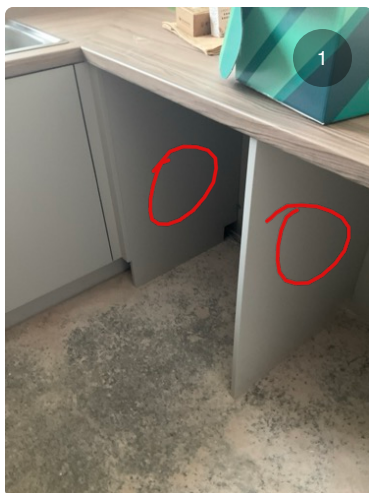
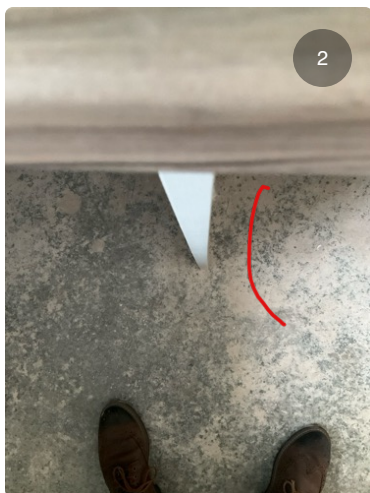
## Issue 32

These two panels, still have the protective film on them.

Middle panel is bowed .

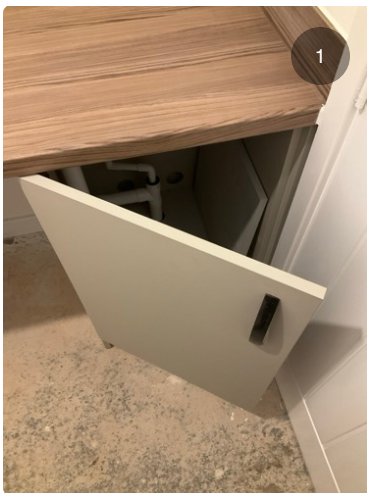
### Issue 39

Shelf in utility cupboard, needs cutting to fit around the pipework.

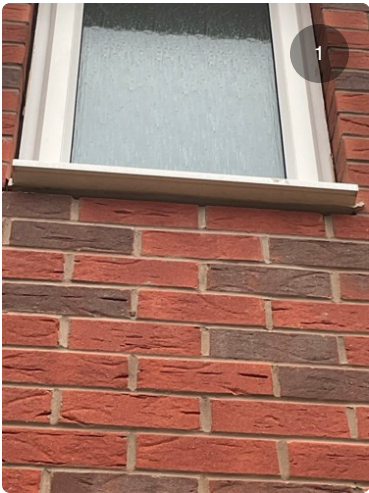
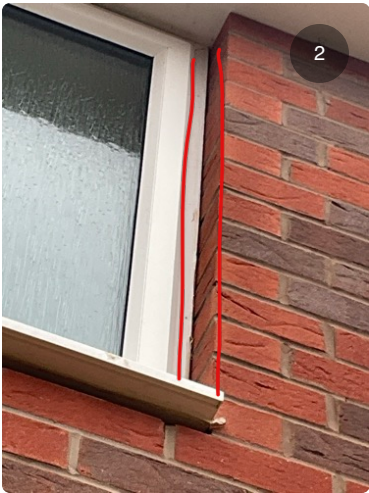
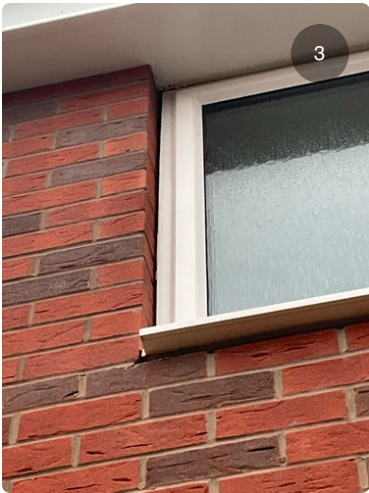
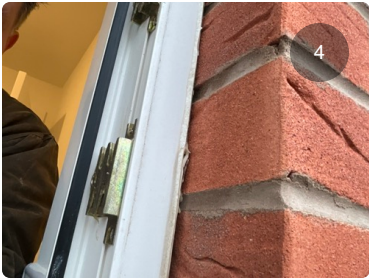
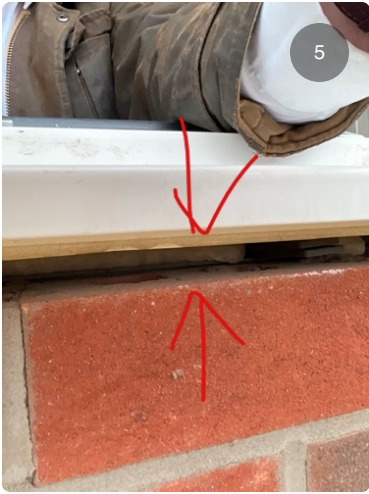
Issue 44

Not sealed sides and under bathroom window.

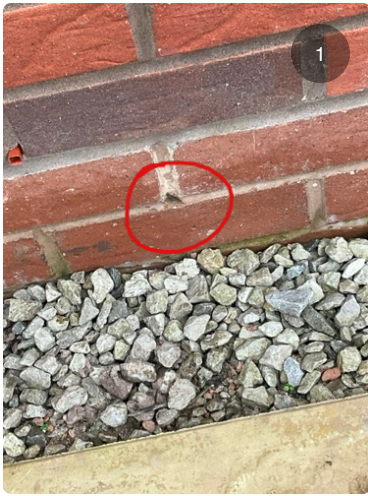
Issue 46

Weep hole blocked, patio door cavity tray.

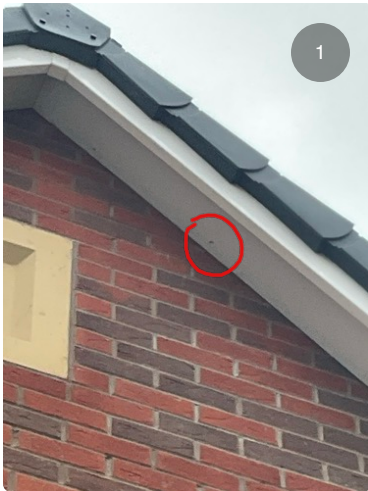
### Issue 47

Pointing, back of house.

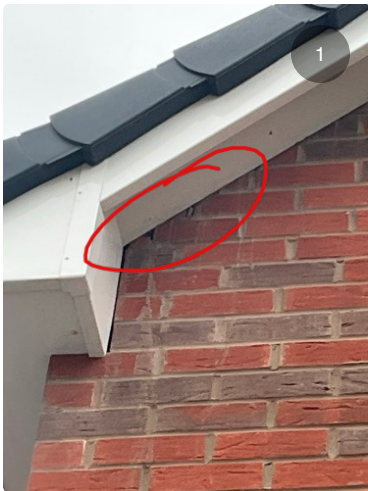
### Issue 48

Screw sticking out of fascia, front of house.

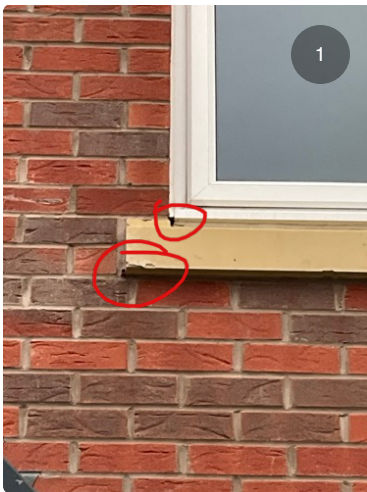
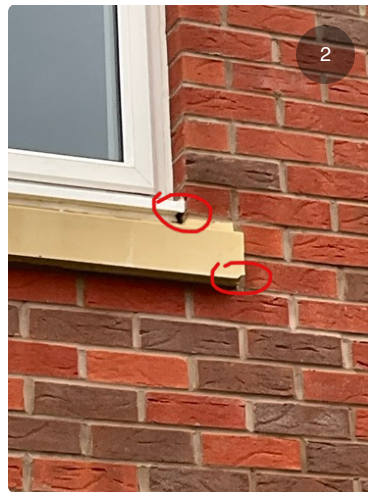
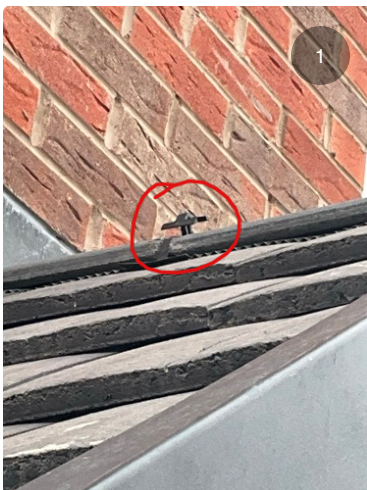
## Issue 51

Chips in stone sill and holes next to window. Upper front window.

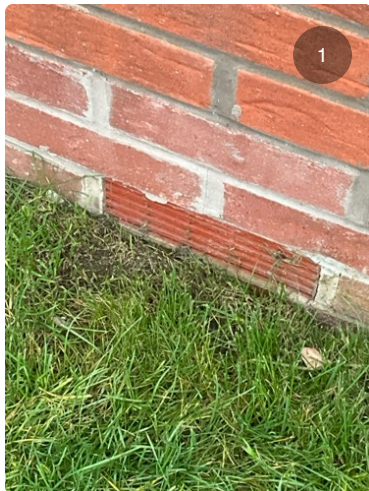
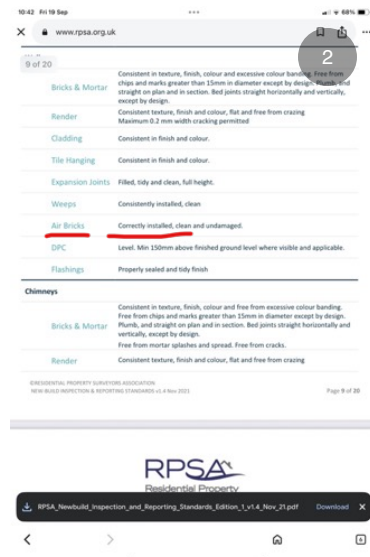
## Issue 56

Danger of cavity flooding through this Air Brick.

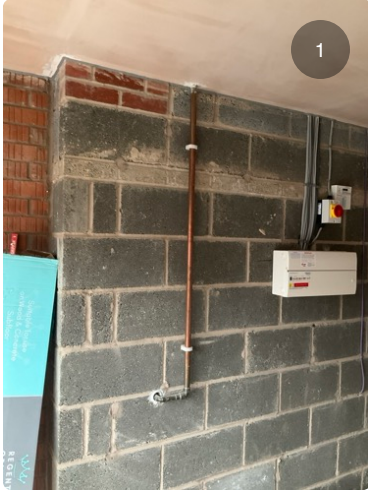
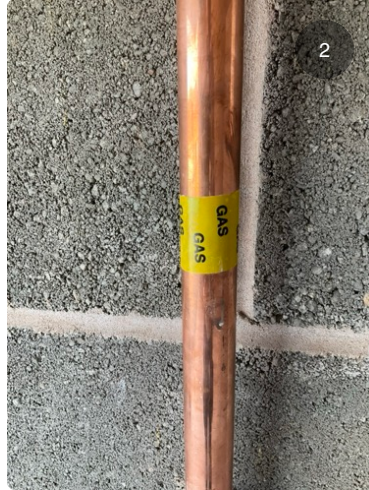
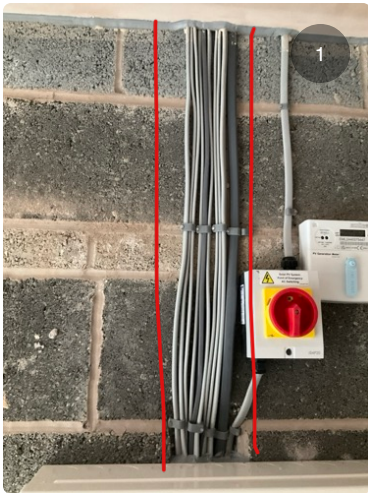
## Issue 57

No GAS identification tape, on gas pipe in garage.

Picture two for reference .

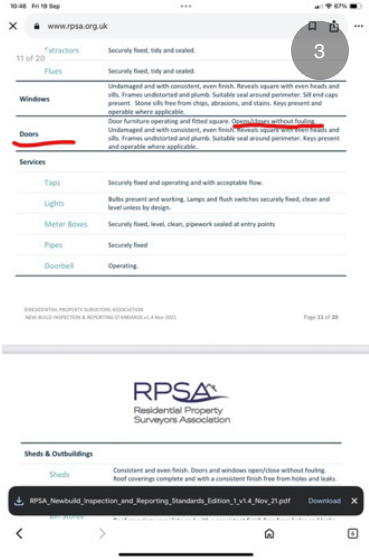
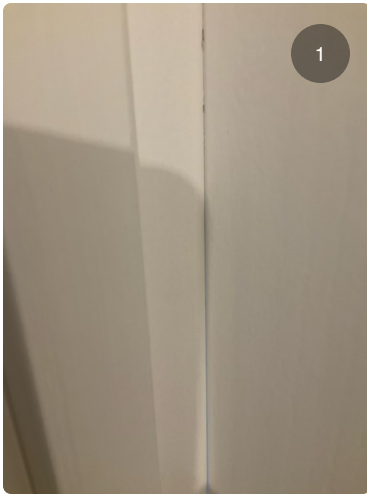
Issue 64

Bedroom two door, hitting door frame.

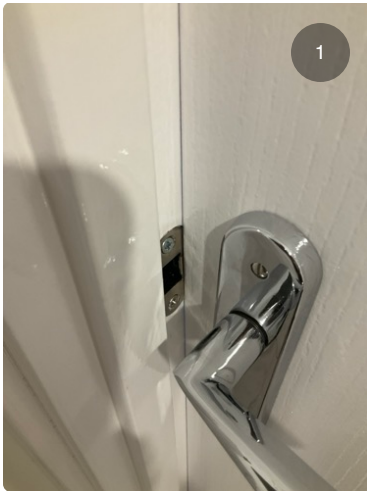
### **Issue 65**

Bedroom three door, hitting door frame. Can't even shut it.

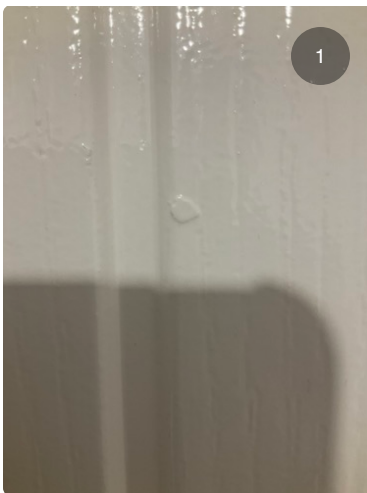
### **Issue 66**

Bedroom four door, hitting door frame.

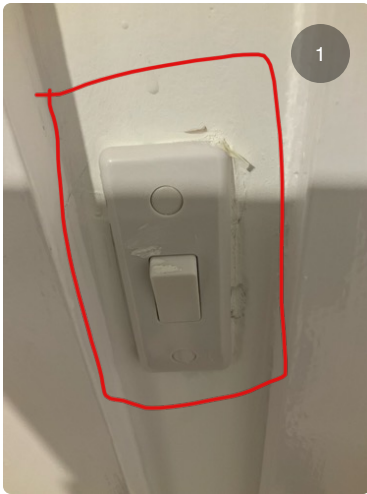
### **Issue 67**

Decoration, bedroom one door.

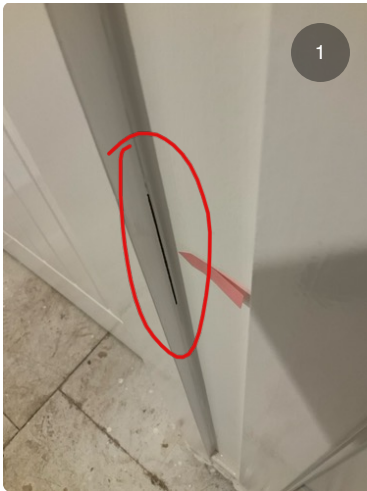
### Issue 68

Decoration, around landing light switch. Light switch is twisted also. Looks horrible.

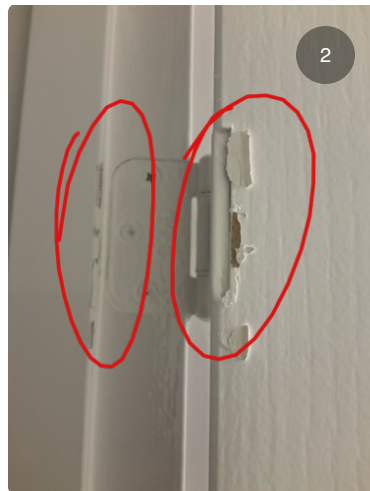
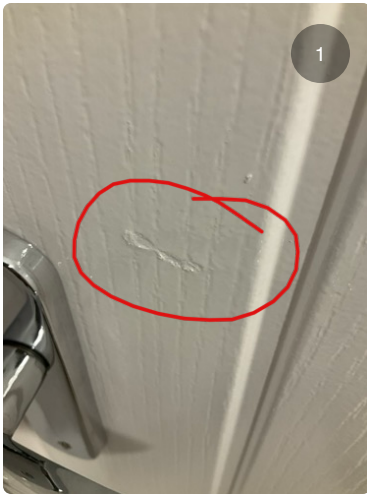
### Issue 70

Decoration, landing cupboard.

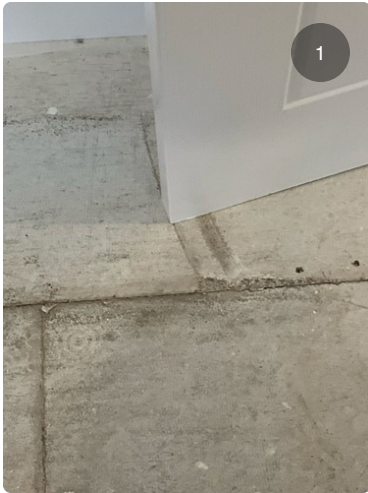
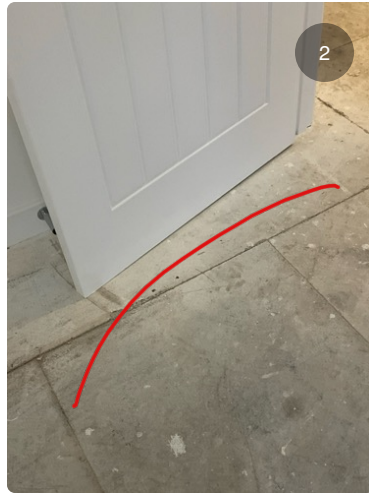
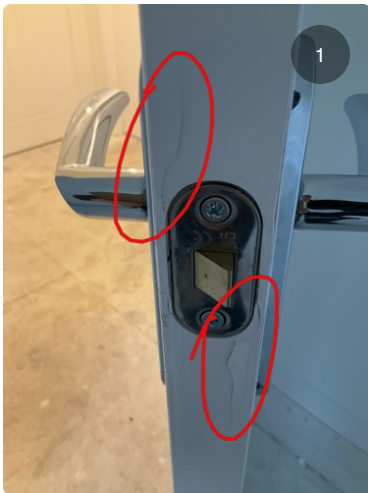
### Issue 74

Bedroom one door catching on the floor. Looks like there's a rise in the floor.

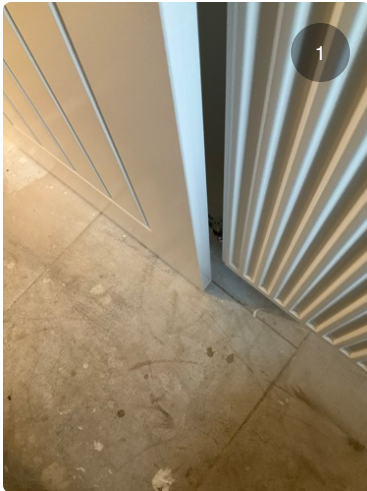
## Issue 77

Line in wall, bedroom 2.

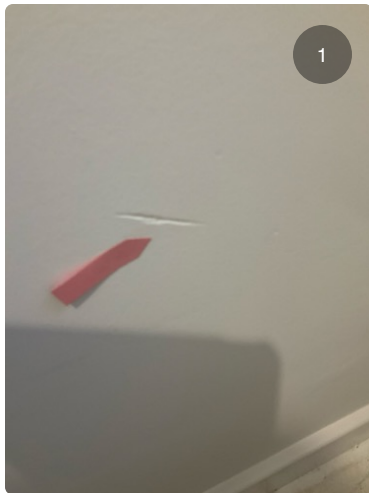
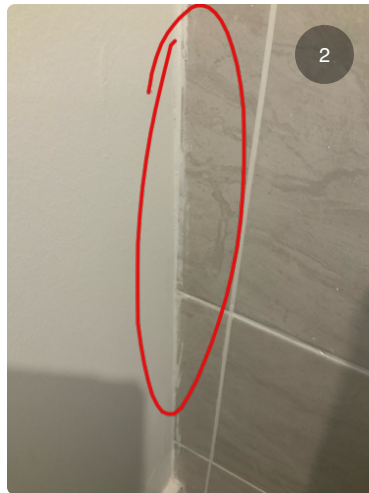
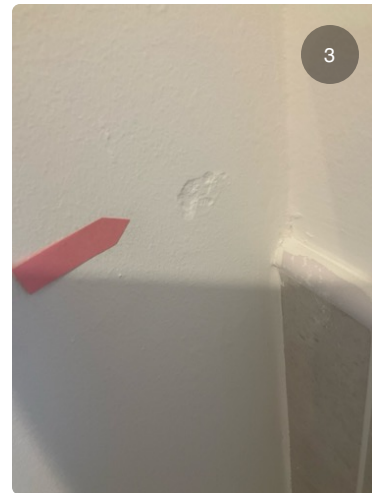
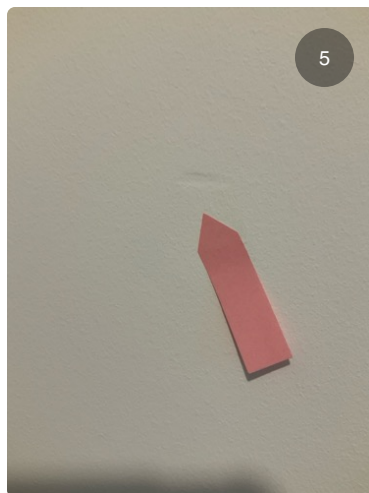
## Issue 80

Decoration, family bathroom.

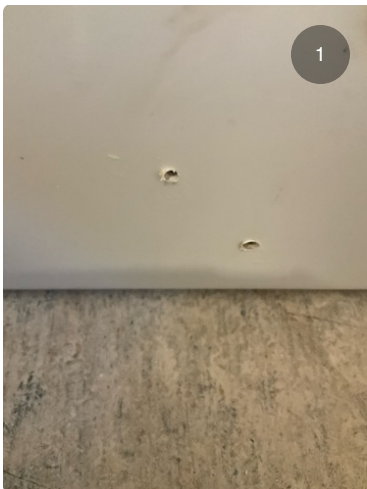
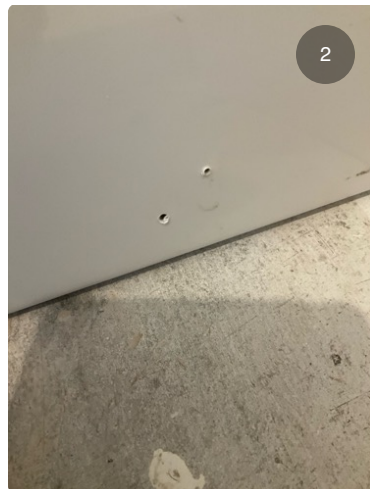
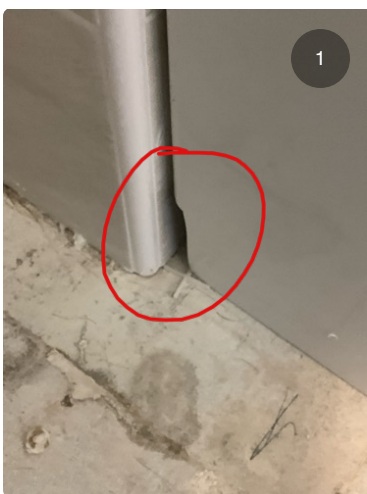
### Issue 85

There is an extra screw hole in the bath panel in all, where all four screws have been.

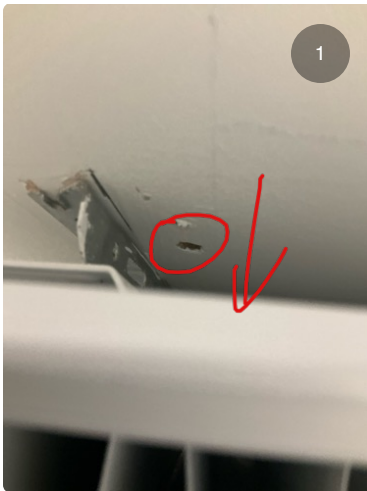
### Issue 90

Holes in the wall behind bedroom 3 radiator. Radiator not on brackets properly, brackets coming away from wall.

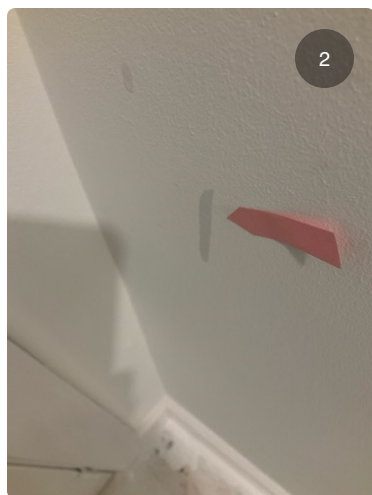
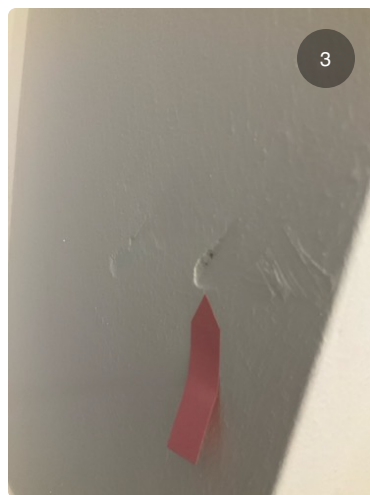
## Issue 95

Decoration, ensuite.

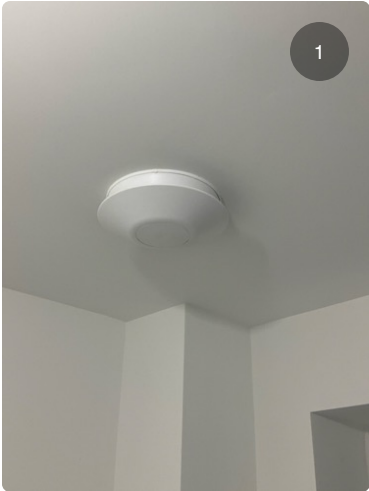
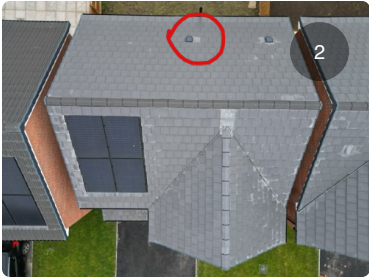
Issue 101

The family bathroom extractor is connected to the circled vent tile in the roof.

The ensuite extractor is not connected to a vent tile in the roof.

I cannot see a vent on the side of the house, or in eaves , therefore I do not believe this is connected to the outside as it should be. If I could see an outlet for it, I would test it with smoke to ensure connection to the outside.
